Pentium® II Processor Specification Update

Release Date: July 1998

Order Number: 243337-016

The Pentium® II processor may contain design defects or errors known as errata which may cause the product to deviate from published specifications. Current characterized errata are documented in this Specification Update.

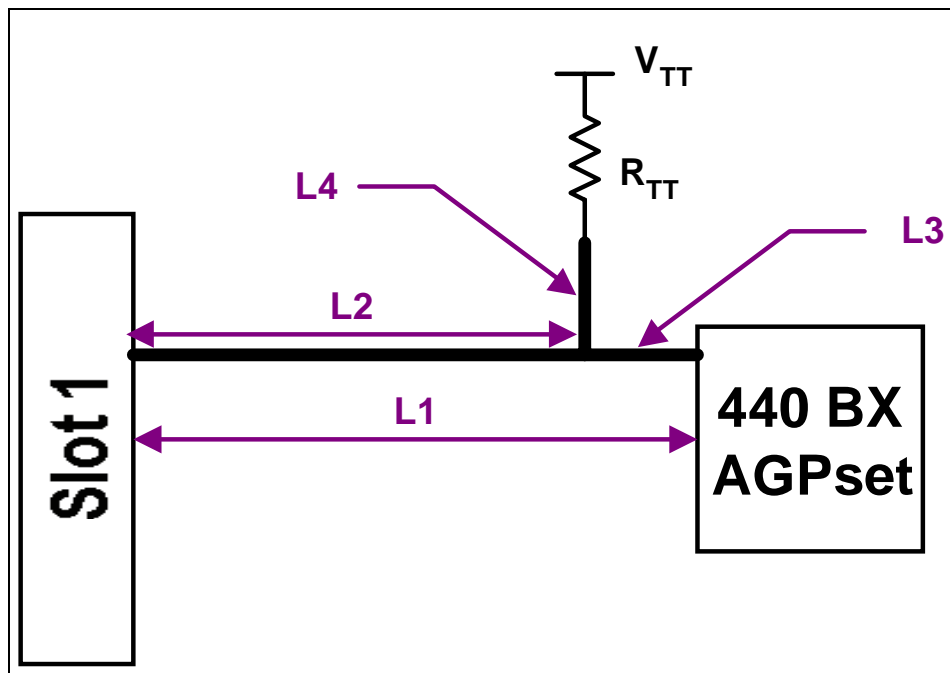
Figure 1. UP Dual Ended Termination (DET)

For UP-DET topologies (see Figure 1), the trace length $L1$ must be between 1.5" to 4.5" while using a 56Ω termination resistor.

WORKAROUND: If the chipset and third party agents used with the Pentium II processor do not optimize their arbitration latency as described above, no action is required. For the 66 MHz Pentium II processor, no action is required. If agents that have implemented this optimization, by following the *100 MHz GTL+ Layout Guidelines for the Pentium® II Processor and Intel 440BX AGPset* for UP-SET (single-ended termination) and DP with both processors installed, no action is required. The following two cases are additional guidelines for UP-DET (dual-ended termination) and DP-DET with only one processor populated.

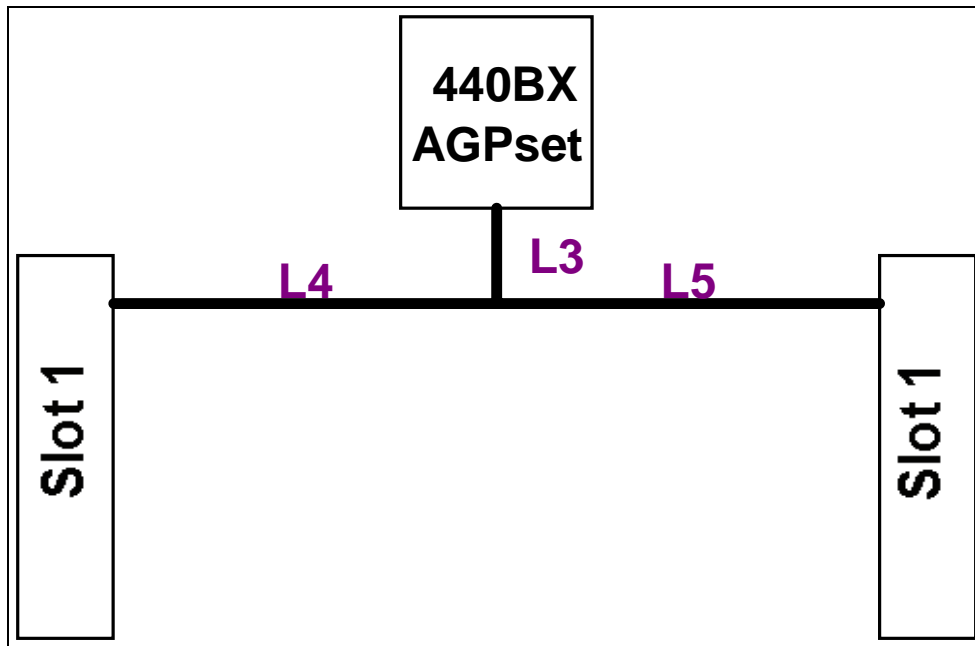
Figure 2. DP Dual Ended Termination (DET)

For DP topologies (see Figure 2) installed with a processor and a termination card, $L4 + L3$

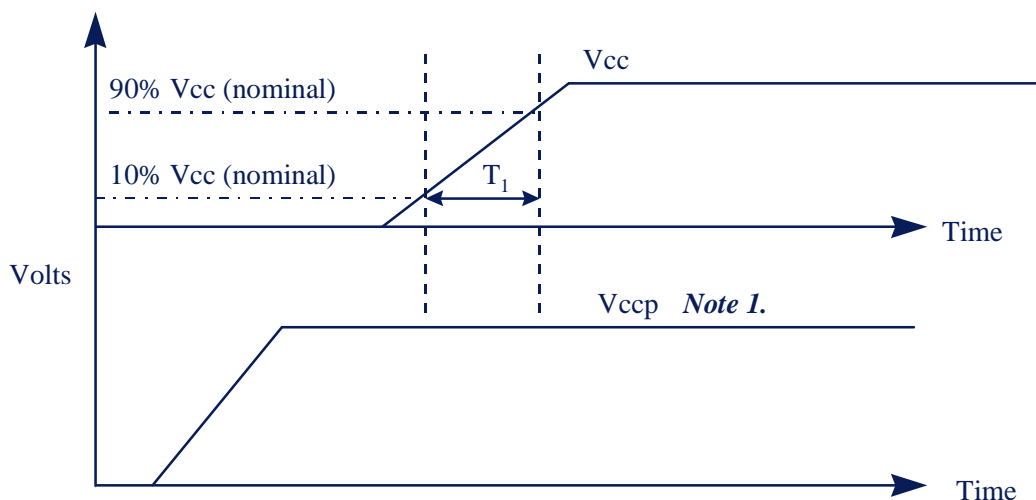
Figure 1. V_{CC}/V_{CCP} Timing Requirements (Mobile)

Symbol	Parameter	Min	Max	Notes
T ₁	V _{CC} Ramp Time	200 uSec		Measured between 10% V _{CC} (nom) to 90% V _{CC} (nom)
<p><i>Note 1: V_{CCP} must be greater than V_{CC} during the interval in which V_{CC} rises from 20% V_{CCP} to 80% V_{CCP}</i></p>

For mobile Pentium II processors, ensure that V_{CC} ramps after or with the L2 cache IO voltage (V_{CCP}). If V_{CCP} ramps after the V_{CC} , a delay circuit can be placed on the core V_{CC} to ensure that V_{CC} ramps at the same time or after V_{CCP} as shown below in Figure 1.

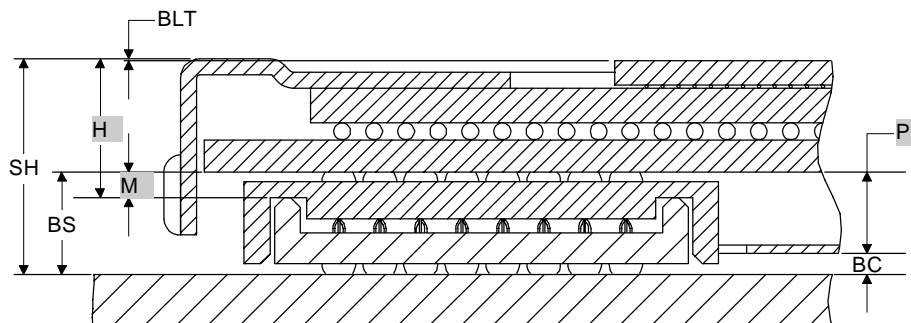
Figure 5.6 Cross Sectional View With Vertical Dimensions

13. Misabeled Vertical Dimension Parameters

Figure 5.6 in the *Mobile Pentium® II Processor at 233 MHz and 266 MHz* datasheet should be replaced by the following figure:
